FORENSIC ENGINEERING REPORT

Cause & Origin Investigation:

Property Address:

Matthew, PE of Triad Forensic Engineering (Triad) performed a site inspection of the Lonker property located at [REDACTED] Boynton Beach, FL on 1/4/2022.

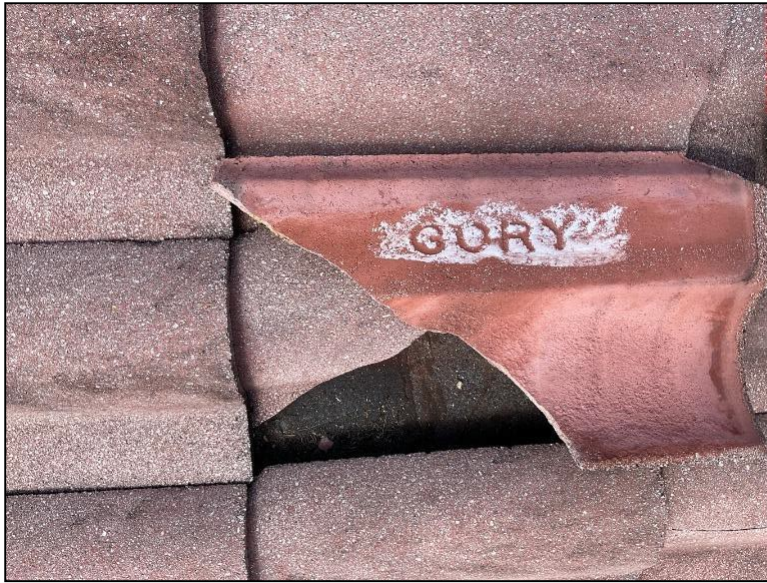
Figure 1

- The roof tiles were stamped with the “Gory” mark. Refer to *Figure 1*.

1. Based on the measurements taken, the amount of roof tiles that were found to be cracked, dislodged, or chipped did not exceed 25% of the roof area. However, a letter prepared by the Tile Roofing Institute (TRI) outlines that “Gory” stamped tiles were “obsolete and do not interlock with profiles currently offered”. This letter is attached to this report for reference. Based on the lack of availability of replacement tiles, and the letter from TRI stating that new tiles do not interlock with the existing tiles, the roof system is recommended to be completely removed and replaced.

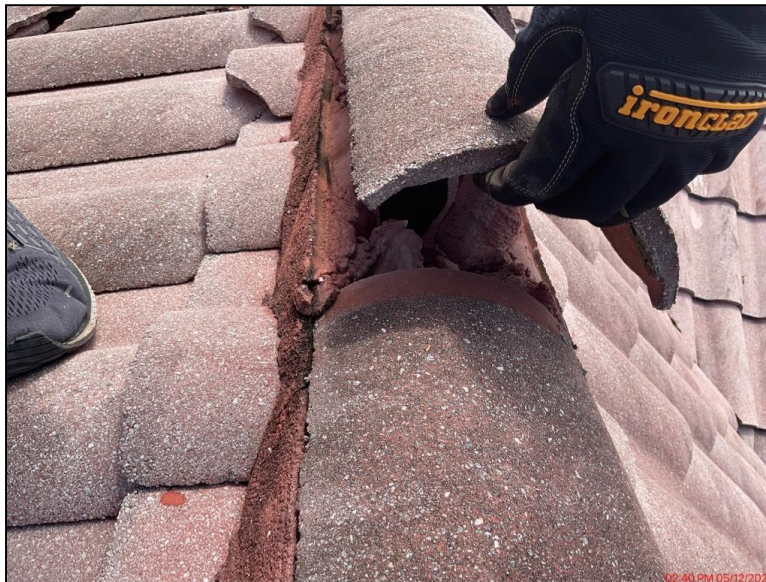
Figure 2

- Sporadic hip and ridge tiles were found to have been debonded from the roof system throughout. Refer to *Figure 2*.

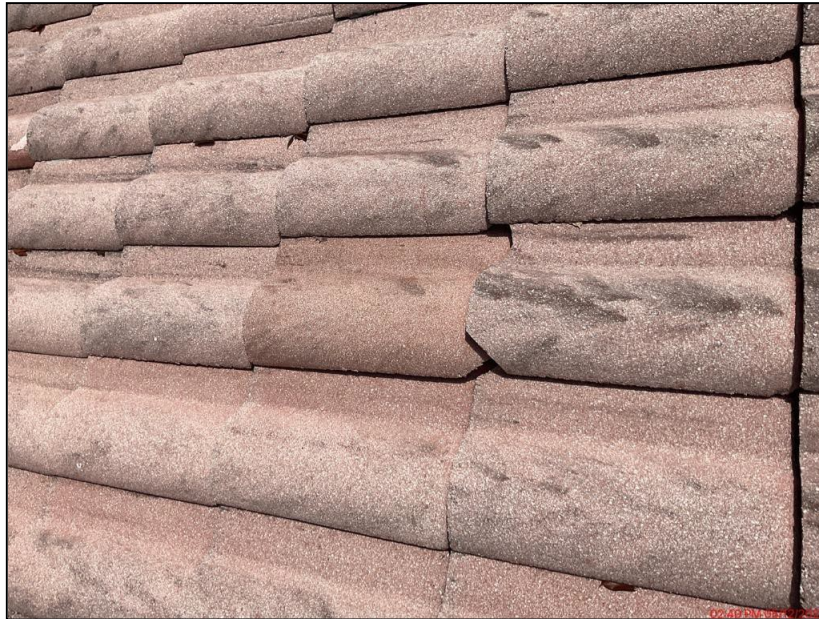
Figure 3

- Sporadic tiles evidenced lower right corner cracking as a result of wind damages during the storm event. Refer to *Figures 3 and 4*.

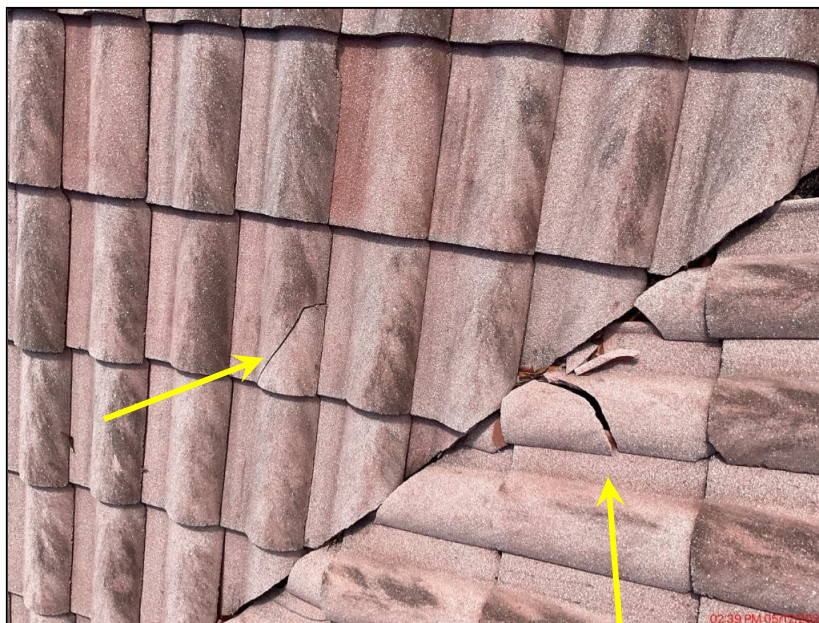
Figure 4

- Larger upper and lower corner tile cracking was observed with sporadic tiles as a result of wind damages during the storm event. Refer to *Figures 4 and 5*.

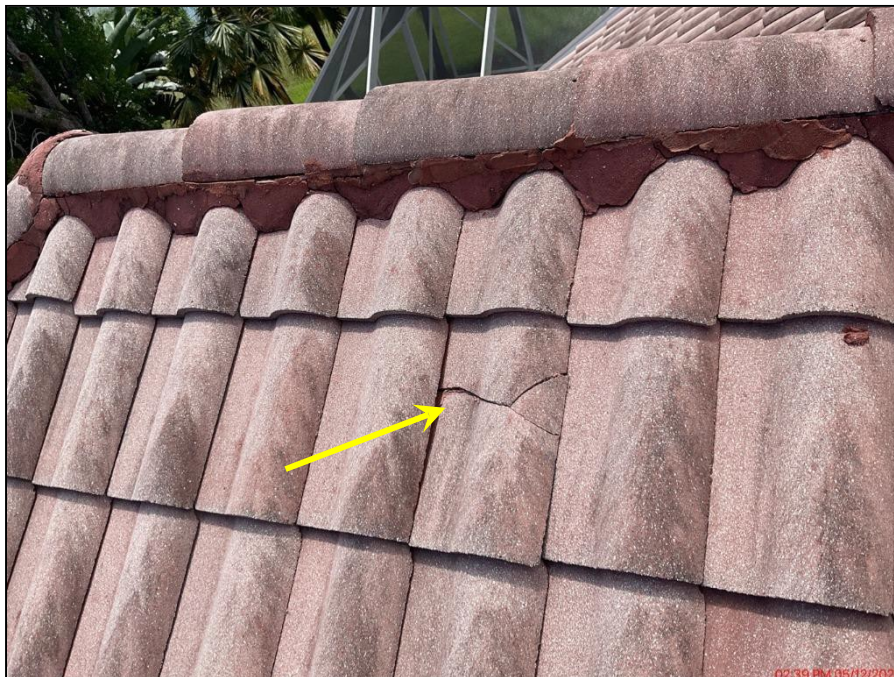
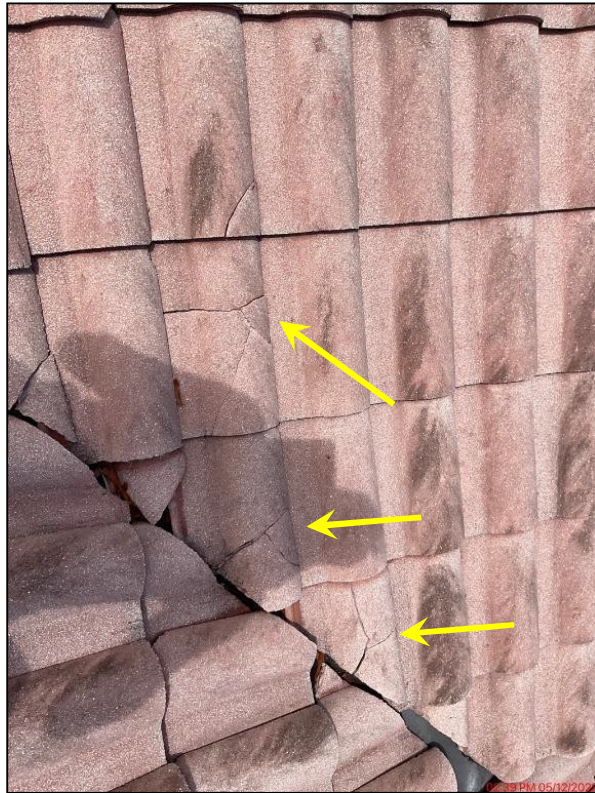
- Spider cracking was observed in several off-ridge and valley tiles as a result of foot traffic damage during previous inspection. Refer to *Figures 6 and 7*.

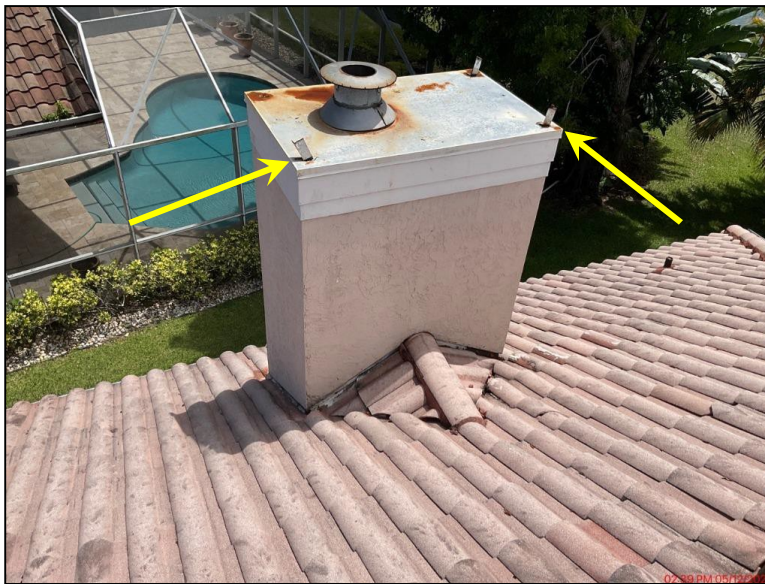
Figure 8

- The chimney cap evidenced having been displaced as a result of wind damages. Refer to *Figure 8*.

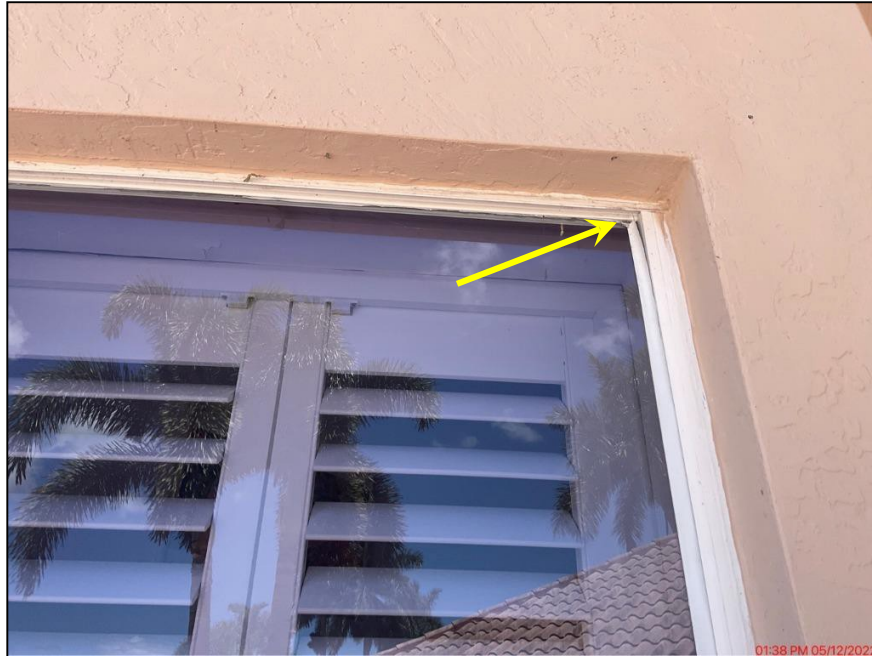
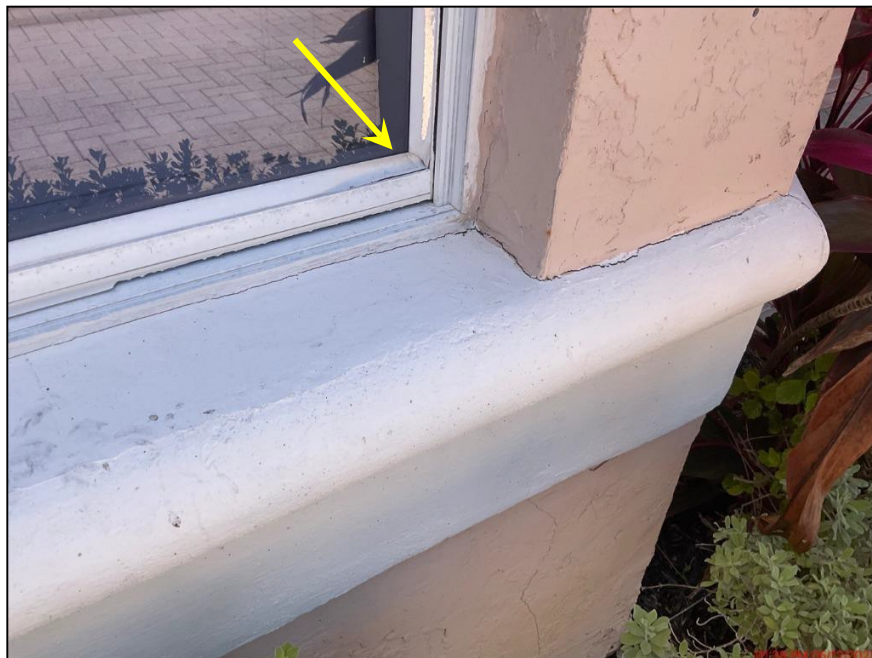
- The windows around the front dining room evidenced bent and/or broken window framing due to flexure during wind loading during the storm event. Refer to *Figures 9 and 10*.

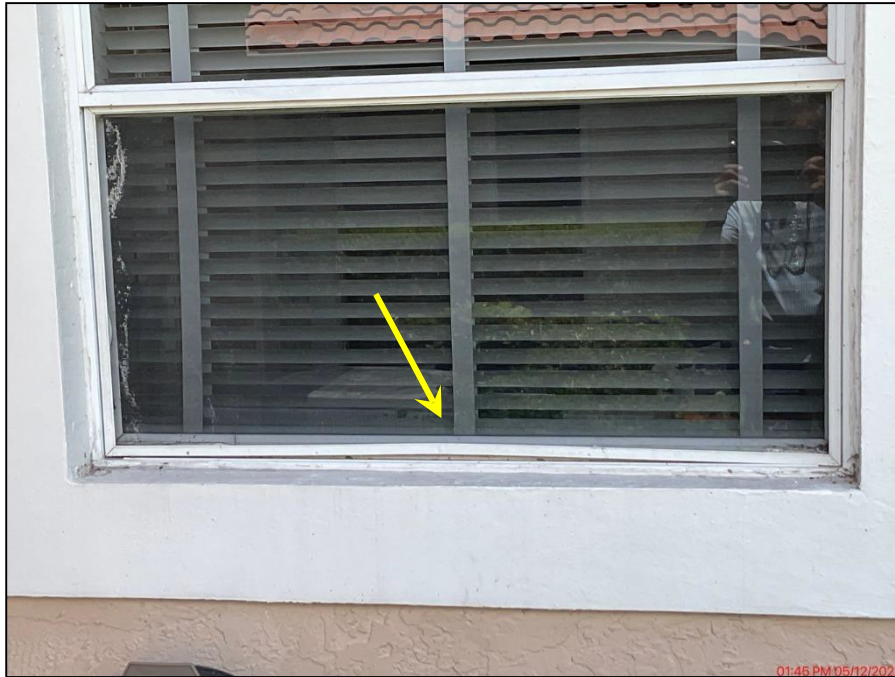
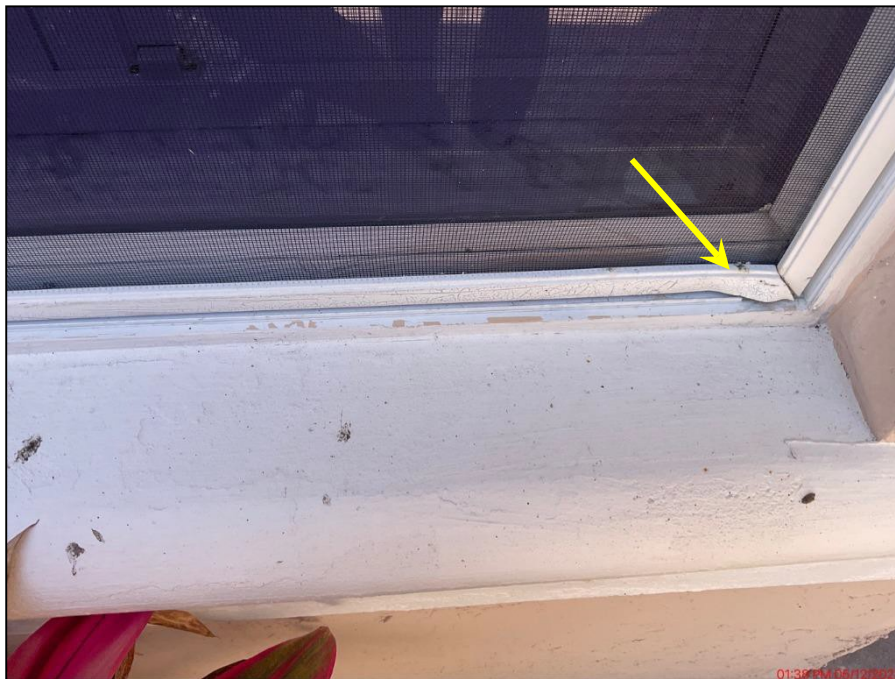
- The window screen frames throughout evidenced bent and/or broken framing due to flexure during wind loading during the storm event. Refer to *Figures 11 and 12*.

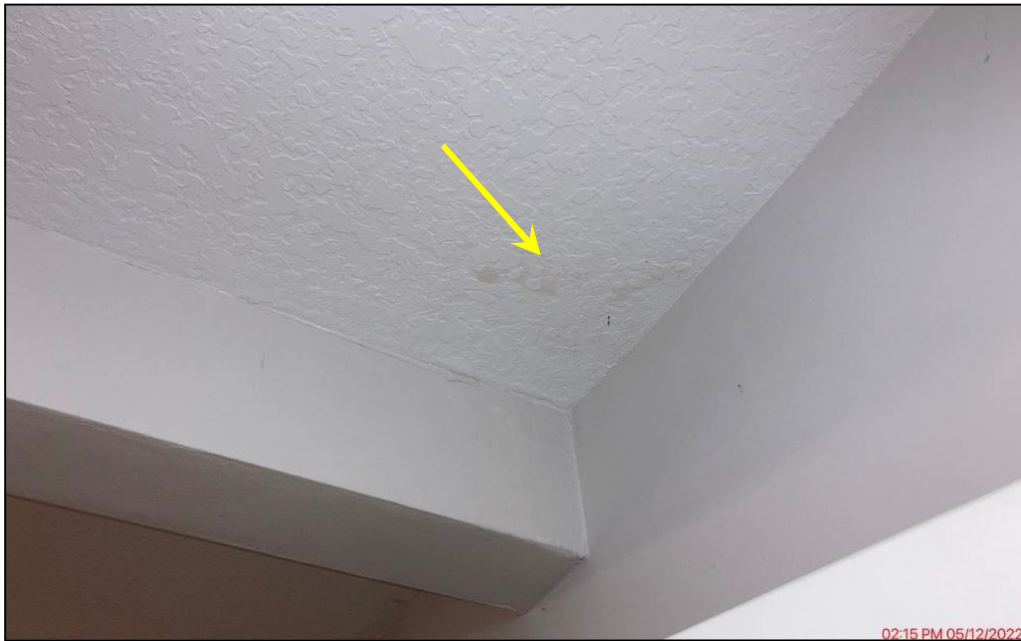
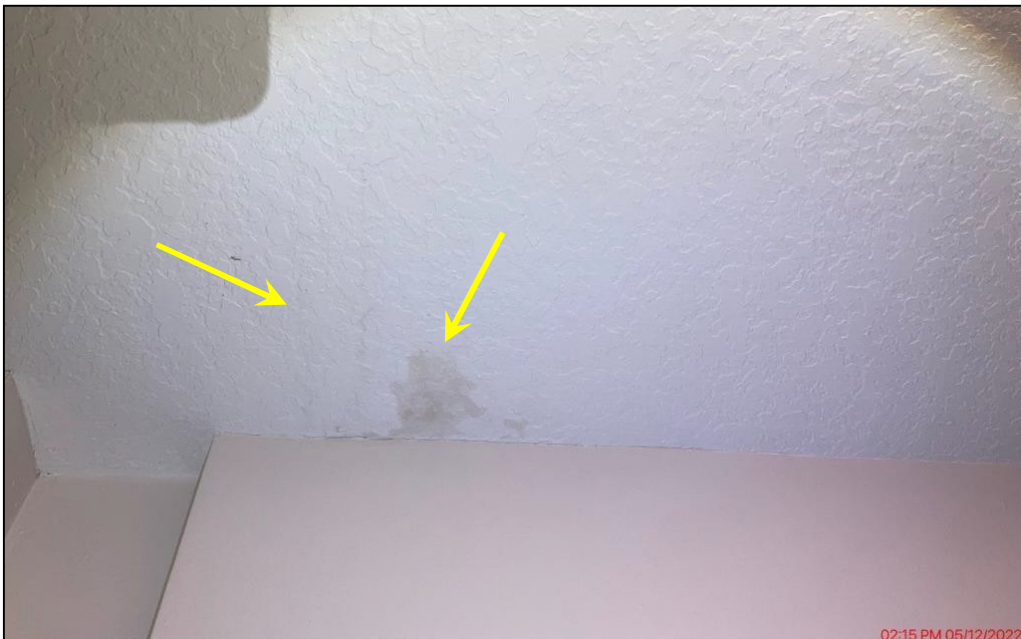
- The garage ceiling evidenced staining as a result of short-term water intrusion through the roof system above during the reported storm event. Refer to *Figures 13 and 14*.

2. During the replacement of the roof system, the roof deck should be surveyed and areas evidencing damages/deterioration should be removed and replaced.
3. Upon removal of the roof system, the roof deck fastening pattern should be inspected for conformance to the *Florida Building Code*. If the deck fastening is found to not conform, the deck should be refastened in conformance with the building code.
4. Any insulation or interior finishes that were affected by moisture or cracking should be removed and replaced.

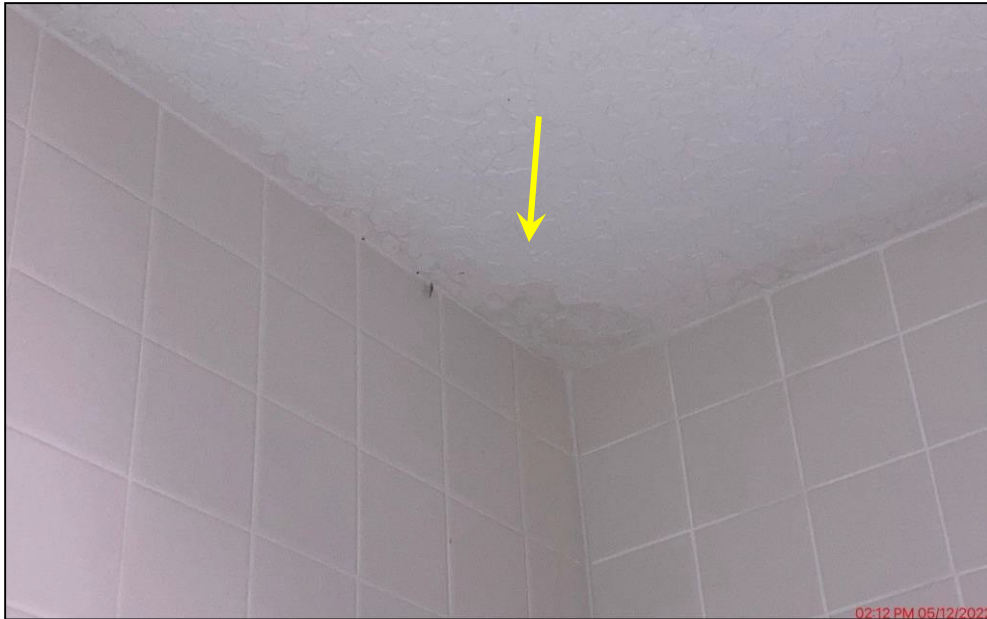
Figure 15

- The ceiling within the bathroom evidenced staining as a result of short-term water intrusion through the roof system above during the storm event. Refer to *Figure 15*.

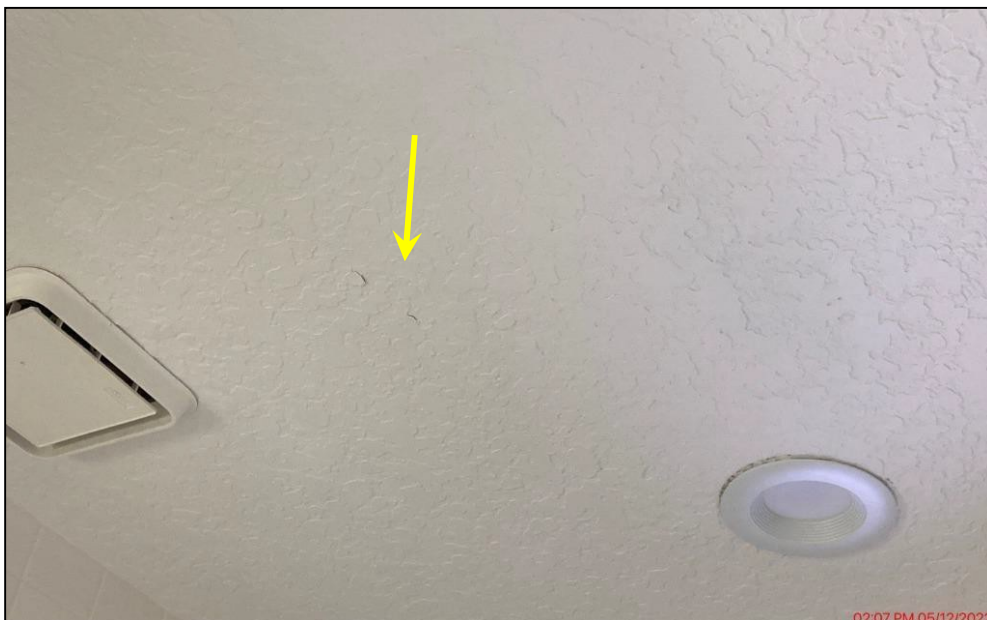
Figure 16

- The ceiling within the hall bathroom evidenced staining as a result of short-term water intrusion through the roof system above during the storm event. Refer to *Figure 16*.

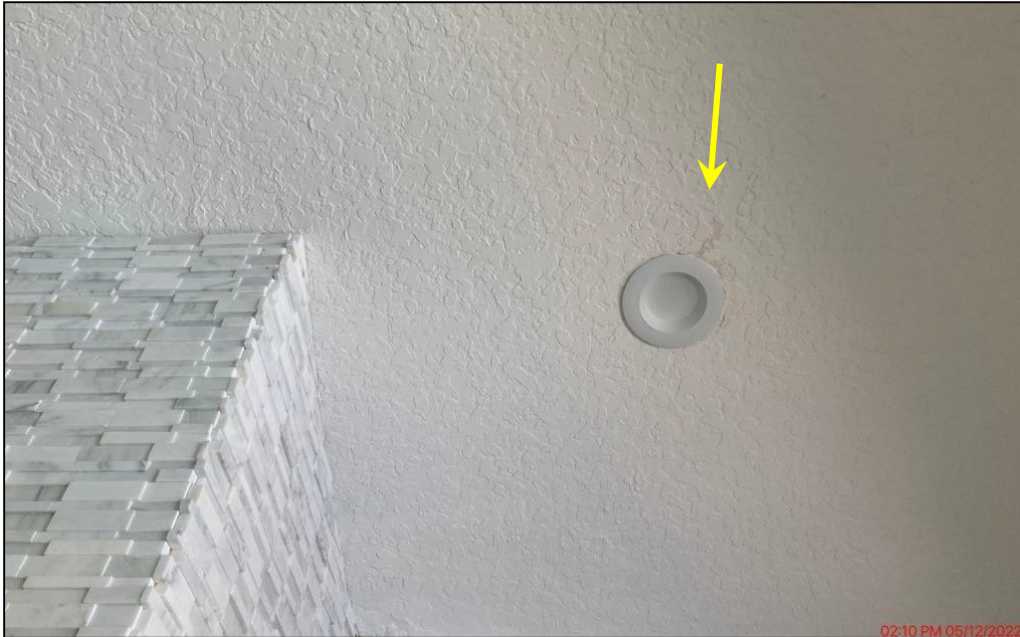
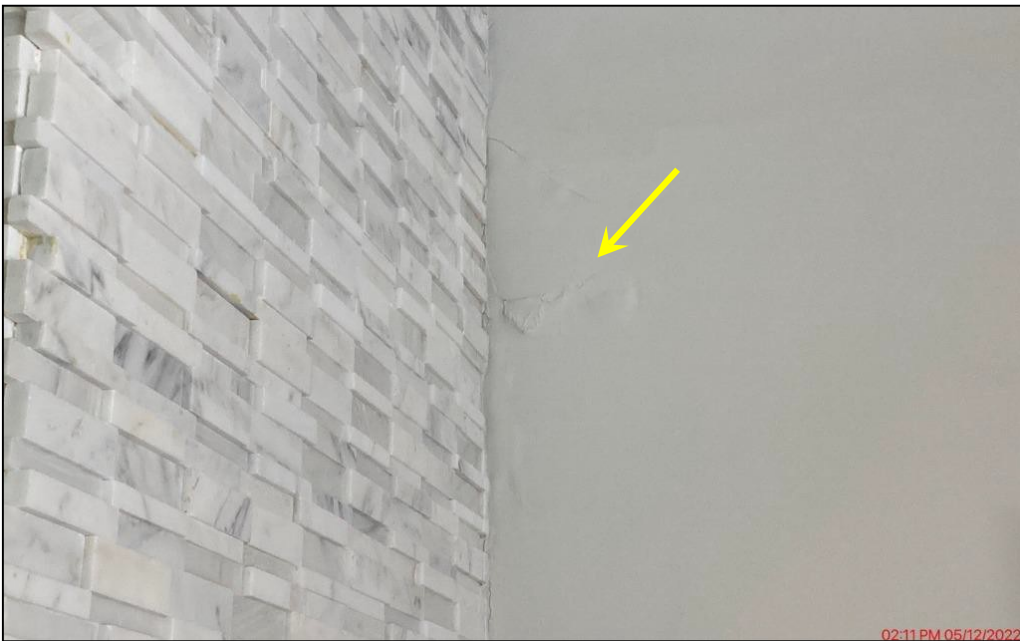
- The ceiling and walls within the family room evidenced staining as a result of short-term water intrusion through the roof system above during the reported storm event. Refer to *Figures 17 and 18.*

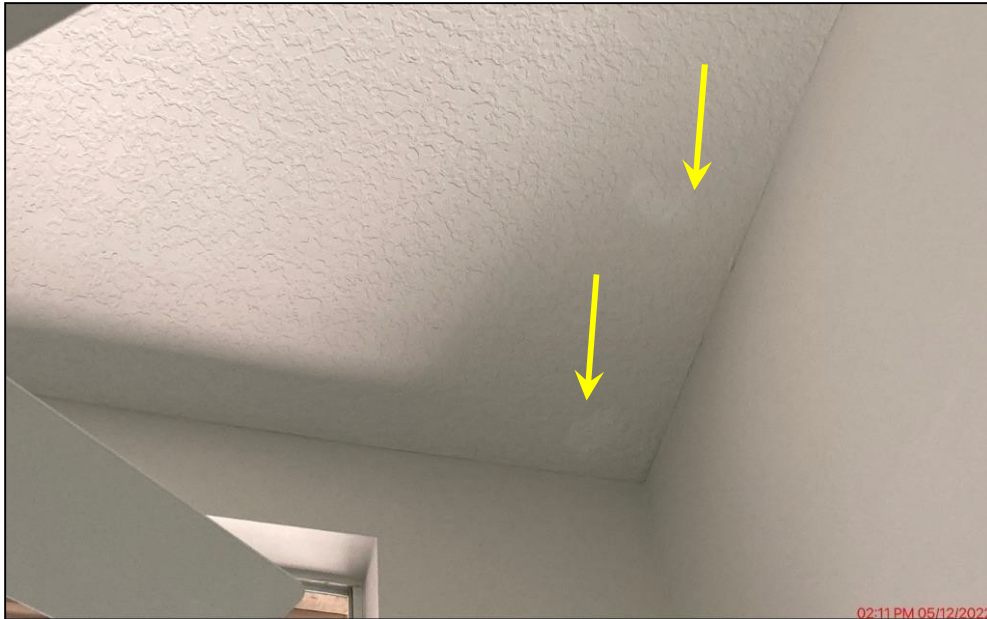
Figure 19

- The ceiling within the office evidenced painted staining as a result of short-term water intrusion through the roof system above during the storm event. Refer to *Figure 19*.

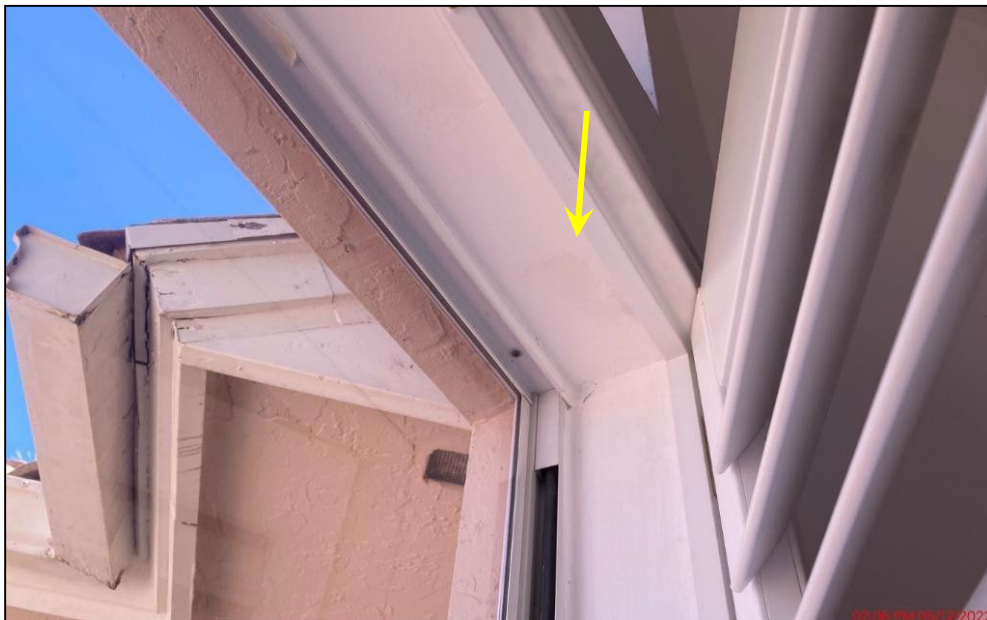
Figure 20

- The windows within the dining room evidenced staining as a result of short-term water intrusion through the window framing during the storm event. Refer to *Figure 20*.

It was also our opinion that, even though the windows were not broken during the storm, wind driven water intrusion occurred through the dining room window components during the storm event. Residential doors and windows that protect a home from weather will leak during a high wind event without damaging the system. Most windows installed in the last five years in Florida have a design pressure (DP) rating of 35-50 pounds per square foot. According to the American Architectural Manufacturers Association, a window with a DP of 35 will have water intrusion in a wind-driven rain of 45 miles per hour, while one with a DP of 50 will have water intrusion in a wind-driven rain of 54 miles per hour. While these window components are rated for zones with much higher wind speeds, that threshold is set for resulting damages sustained from wind pressures or wind-borne debris. Lower speed windstorms can cause water intrusion without permanently damaging the window system itself.

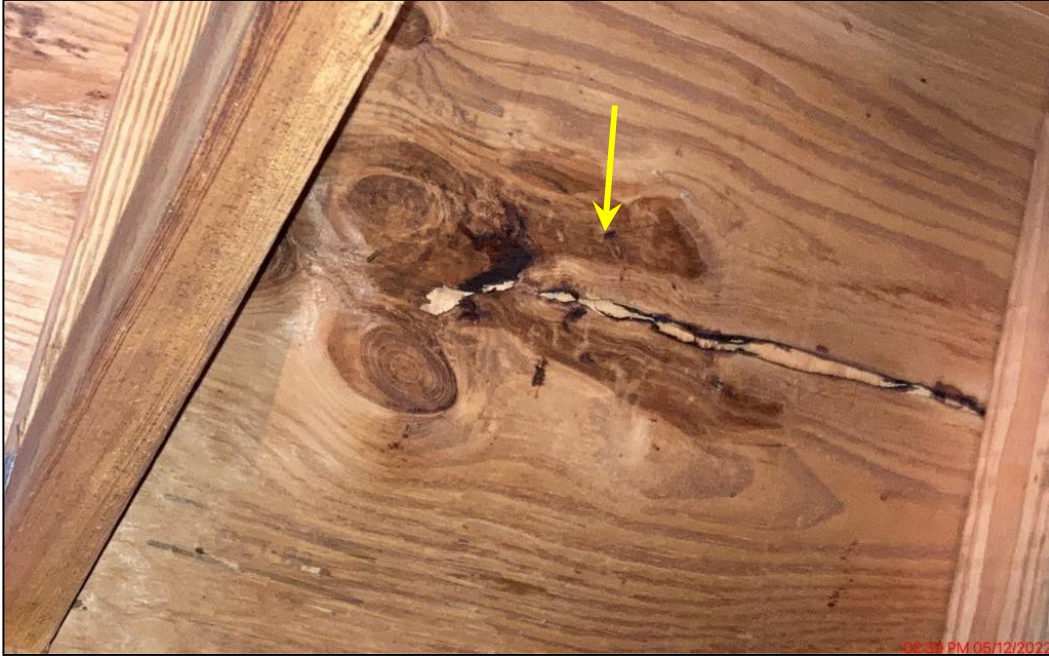
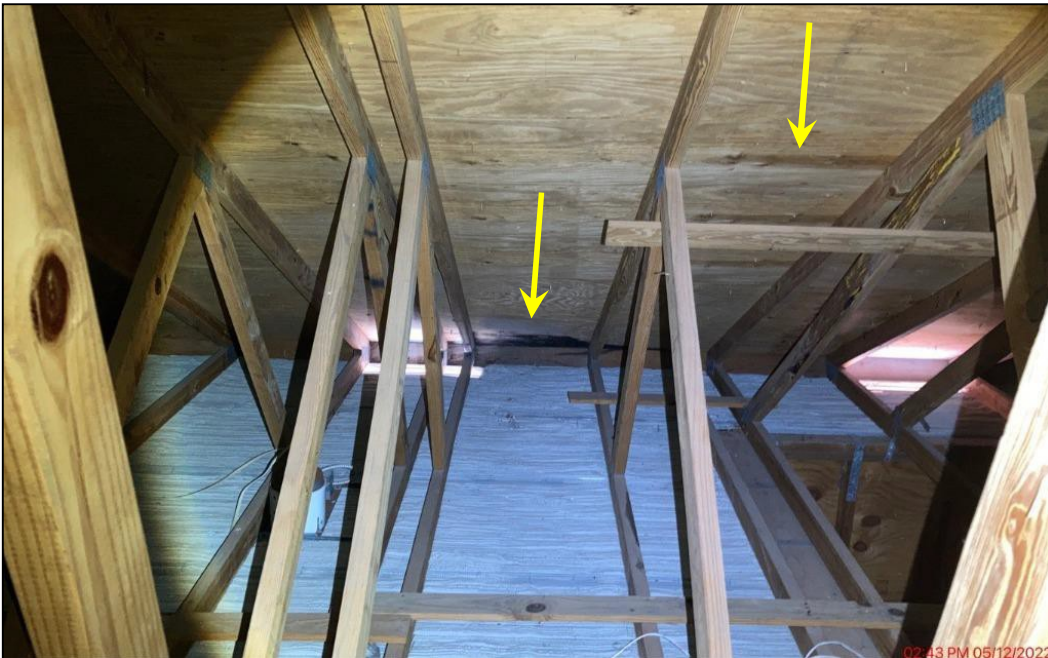
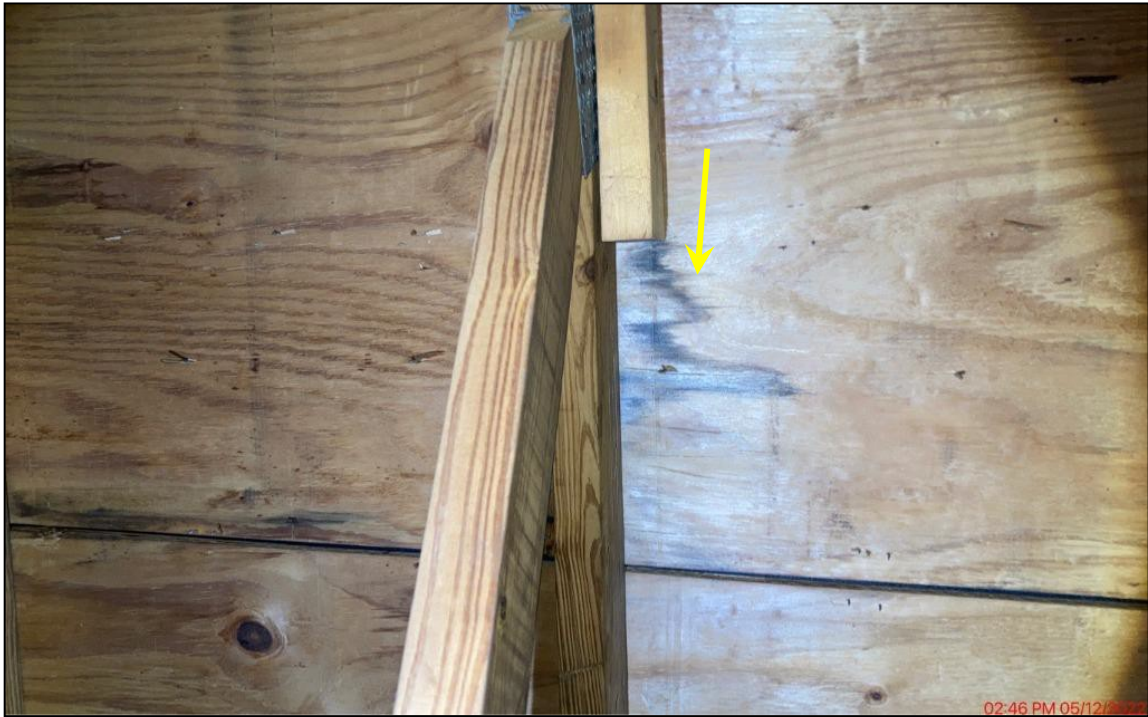
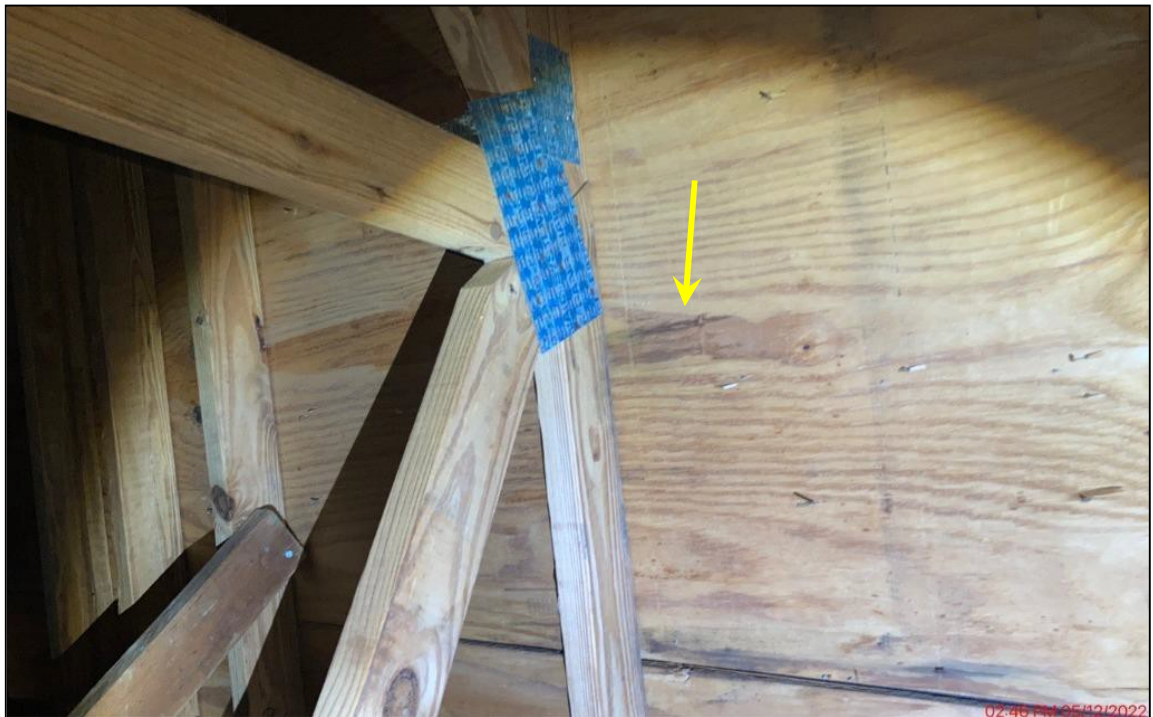
- The attic space evidenced staining of the plywood decking as a result of short-term water intrusion through the roof system above during the storm event. Refer to *Figures 21 to 24*. Note, these areas of staining were no located at points of flashing.

The tiles were observed to be mechanically attached to the roof deck. During high wind events, mechanically attached tiles are known to “chatter” which can cause tiles to crack and/or become dislodged. Tiles can also break during high wind events due to wind-borne debris impacts. These conditions were observed at the Lonker roof as a result of windstorm damages. The “chattering” of the tiles can also cause the mechanical attachments to enlarge the holes in the underlayment and subsequently create points for moisture intrusion to occur. The attic evidenced multiple areas of staining to the underside of the plywood emanating from roof fastener locations.
