THERMAL IMAGING & MOISTURE MAPPING

Thermography Inspection

Moisture Report

Client:	██
Property Owner:	██
Property Address	██
Inspection Date/Time:	2:30 PM December 15, 2022
Building Type:	Residential
Inspection Type:	Cast Iron Pipe
Year Built:	1965
Drainage Type:	Septic
Foundation Type:	Slab
Crawlspace Access Dimensions:	n/a
Crawlspace Joist Height:	n/a

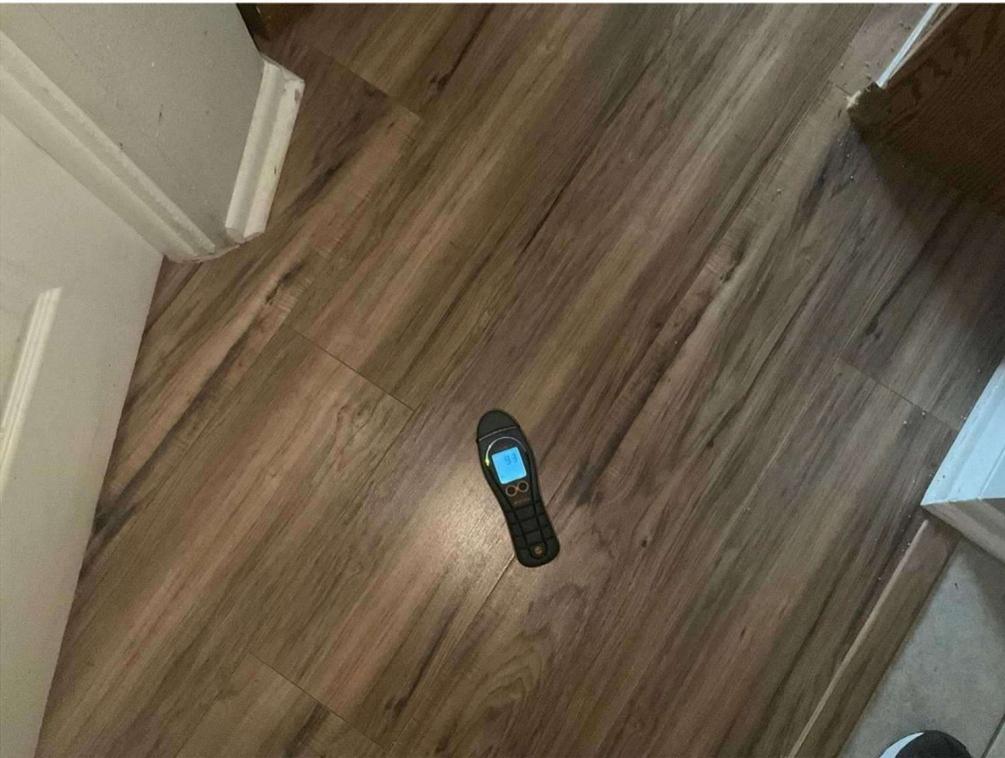
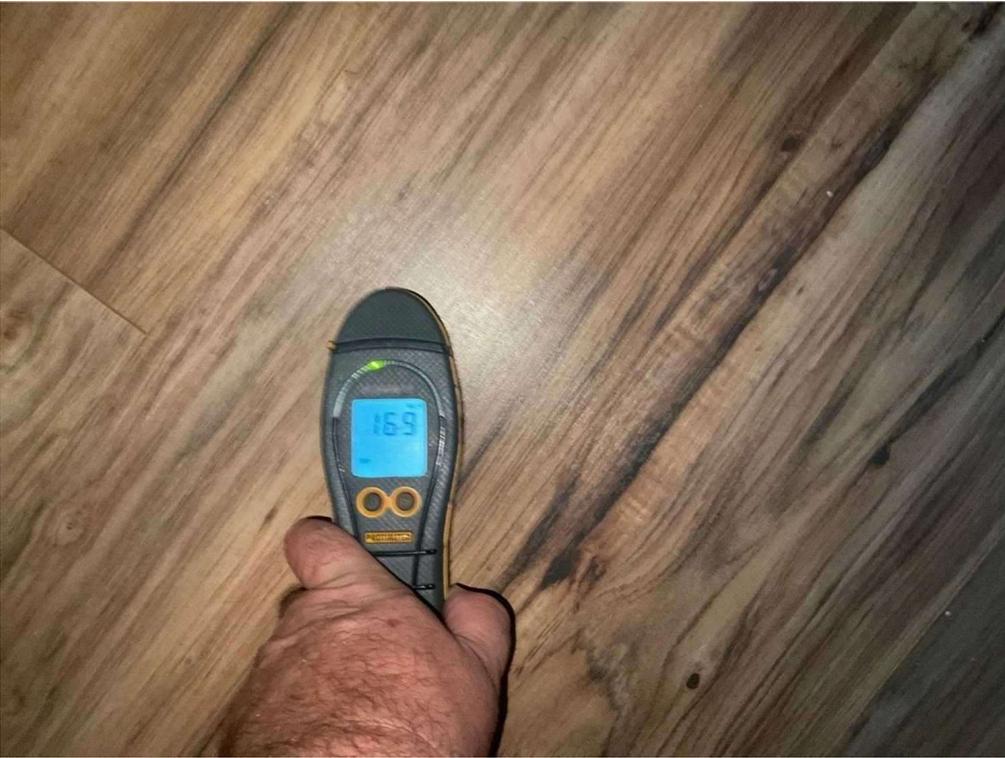
Floor Point 1

169

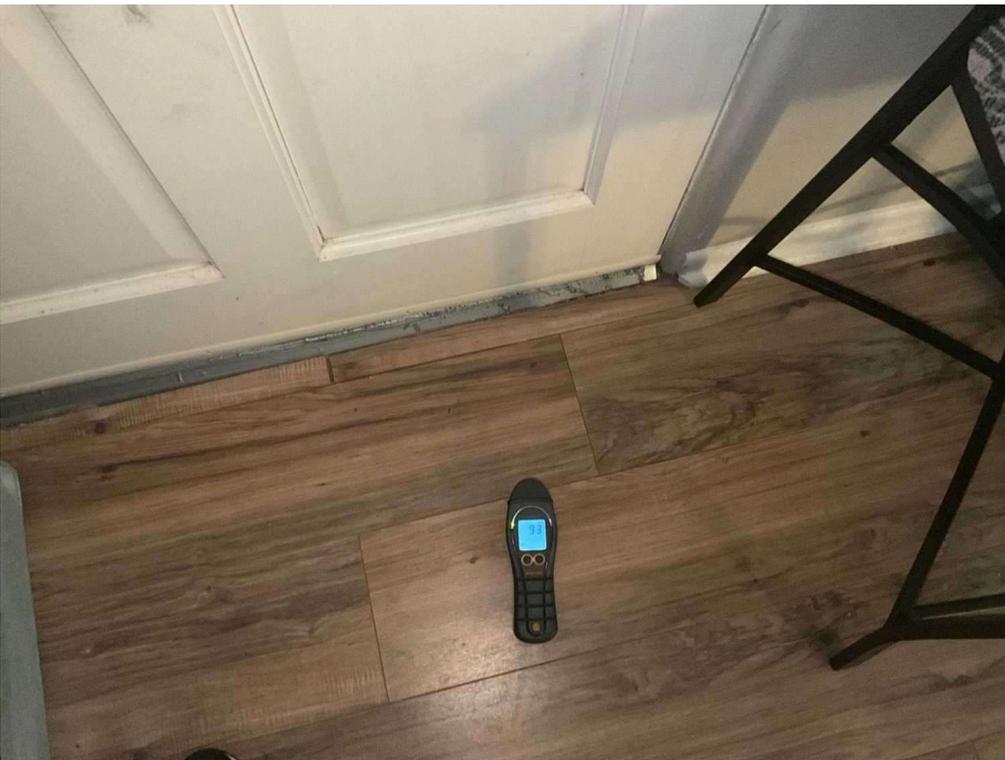
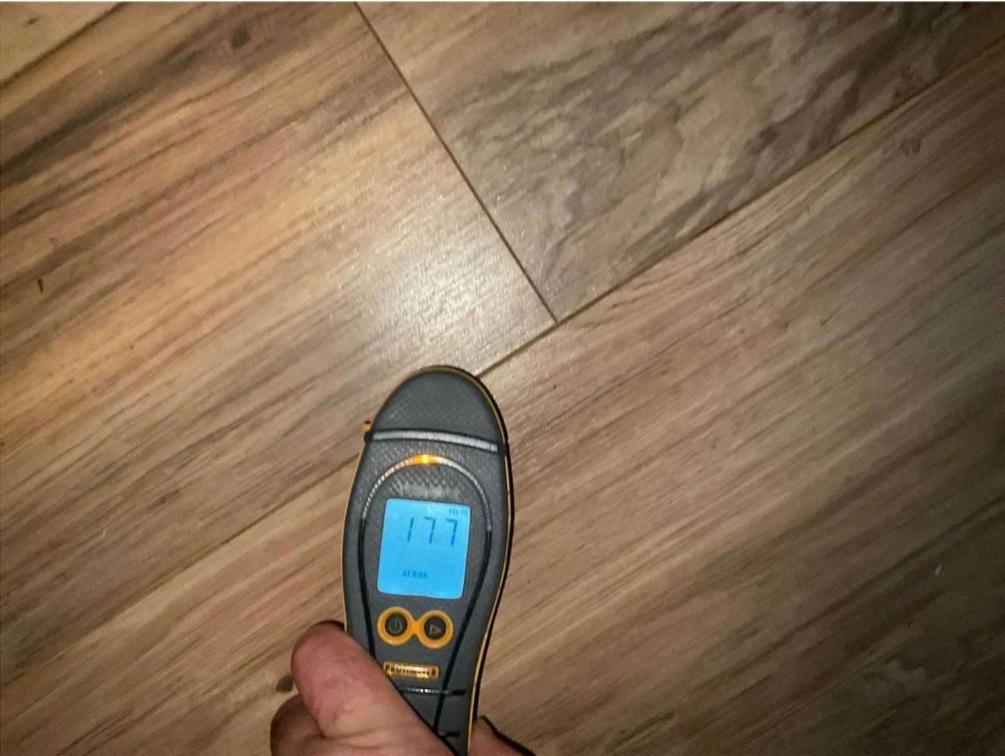
Floor Point 2

177

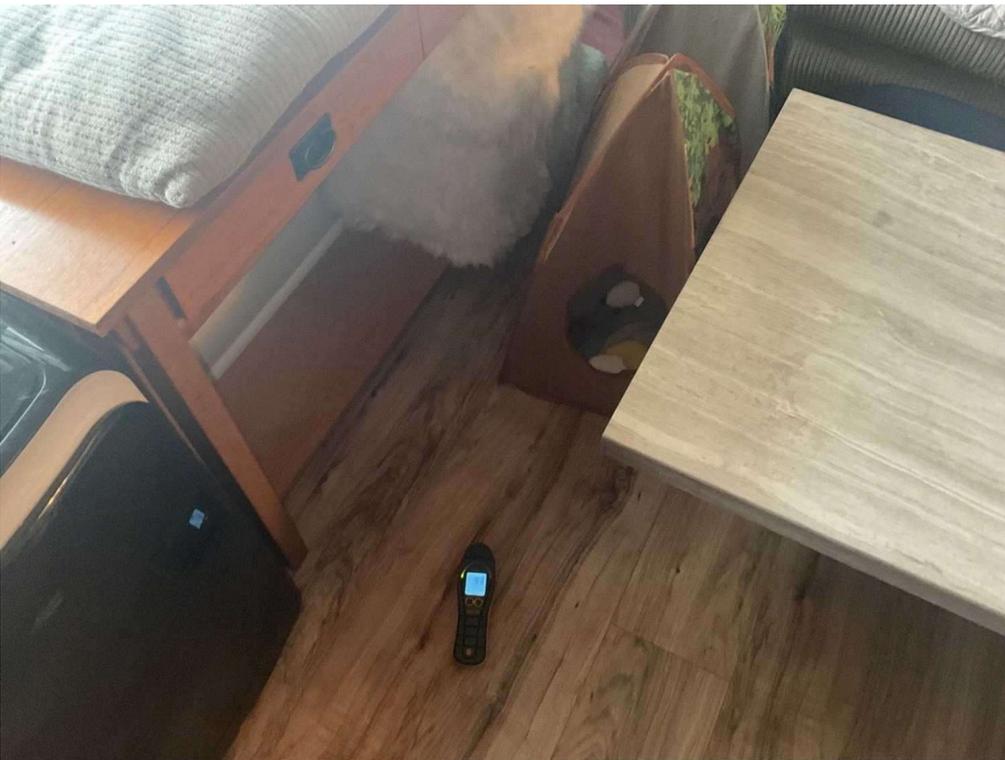
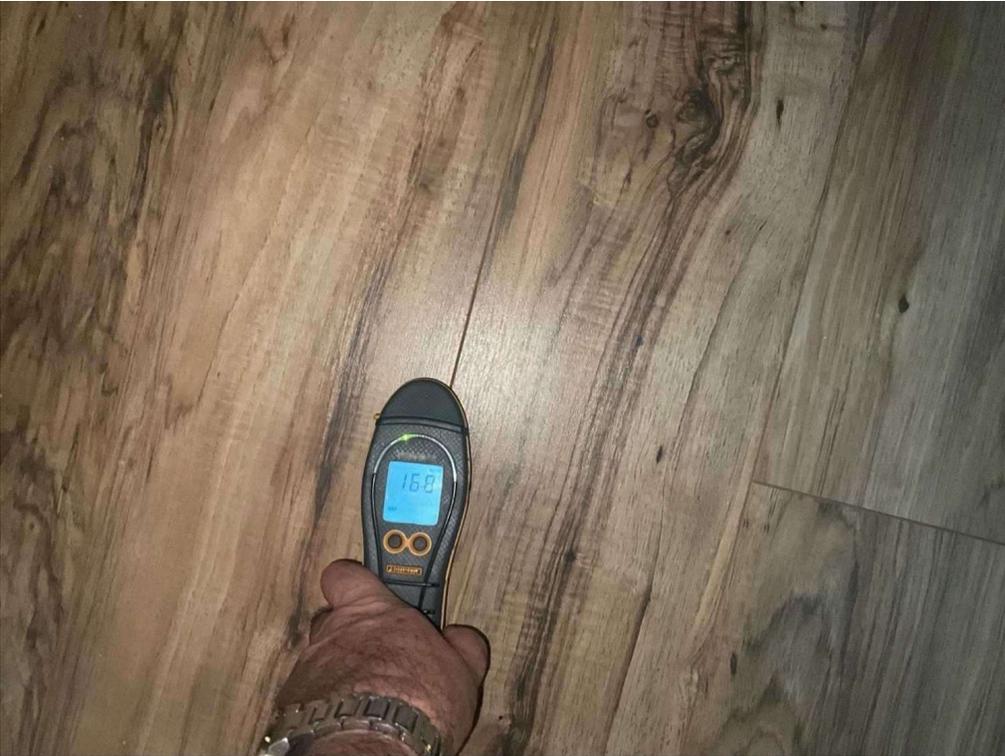
Floor Point 3

168 Dry standard for material

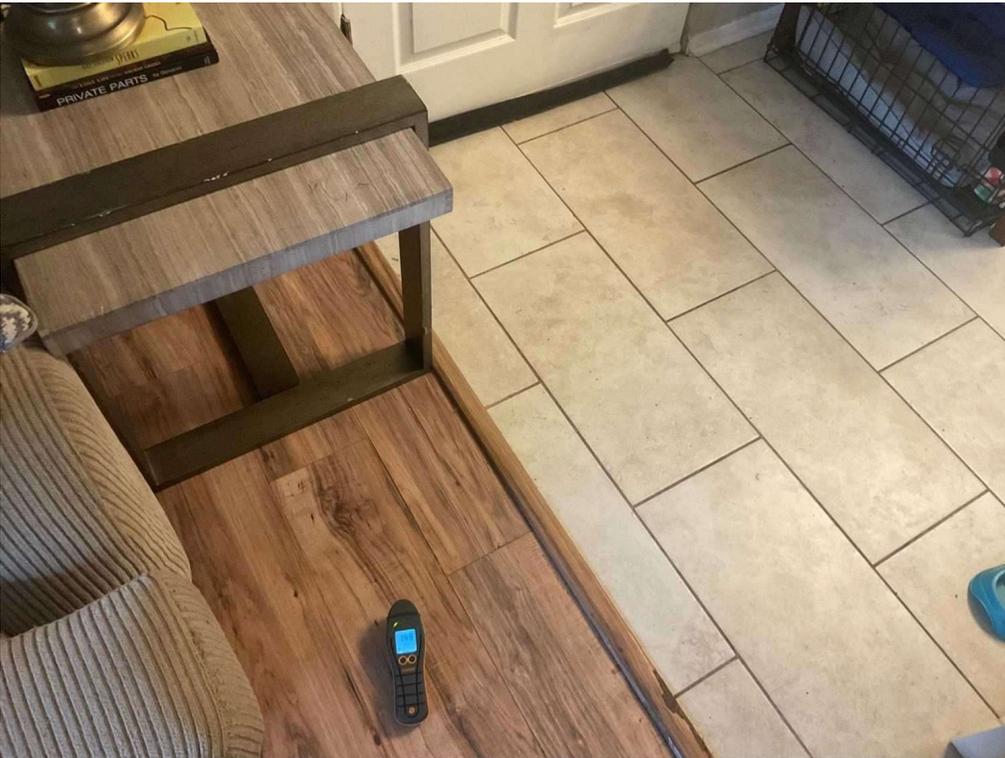
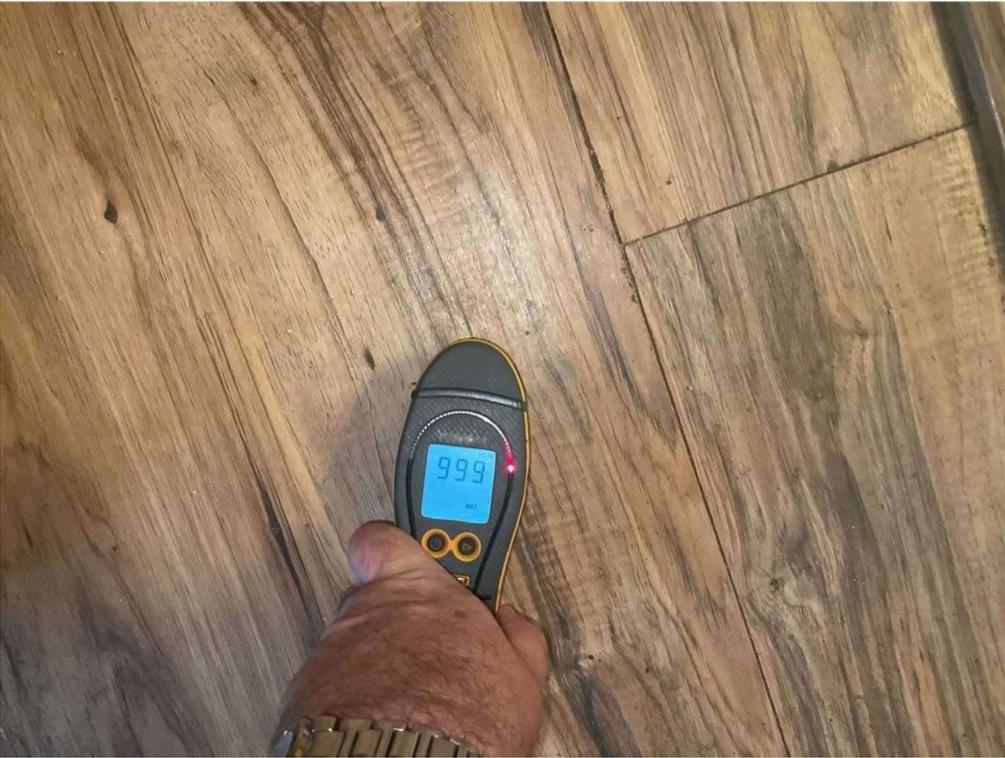
Floor Point 4

999 Elevated

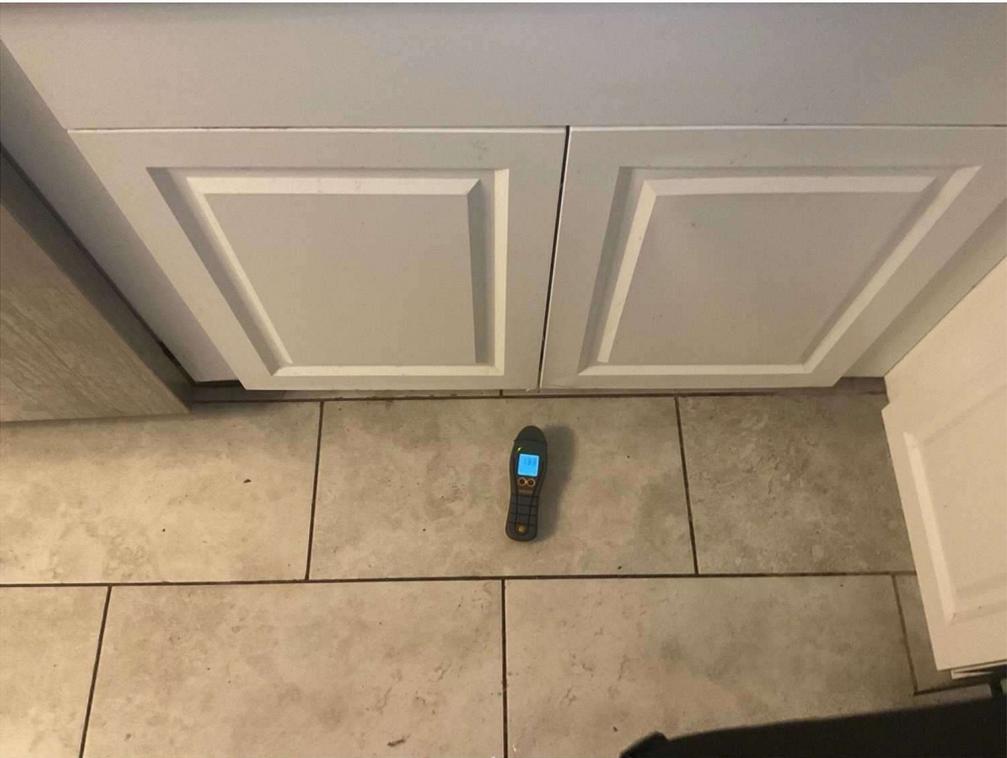
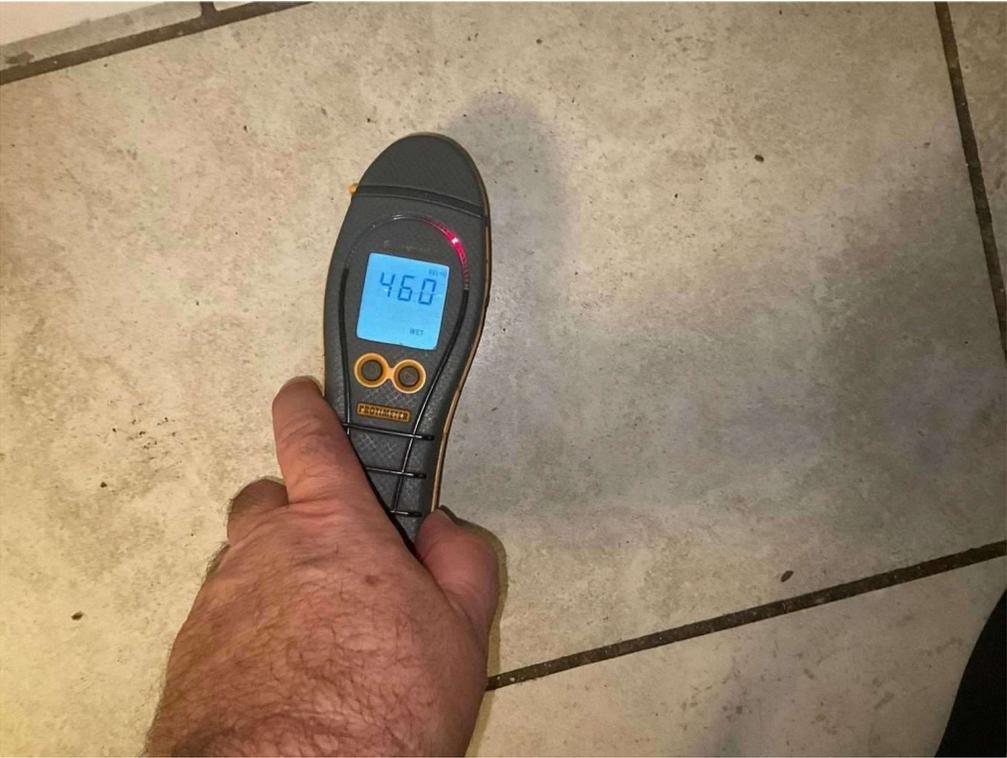
Floor Point 5

460 Elevated

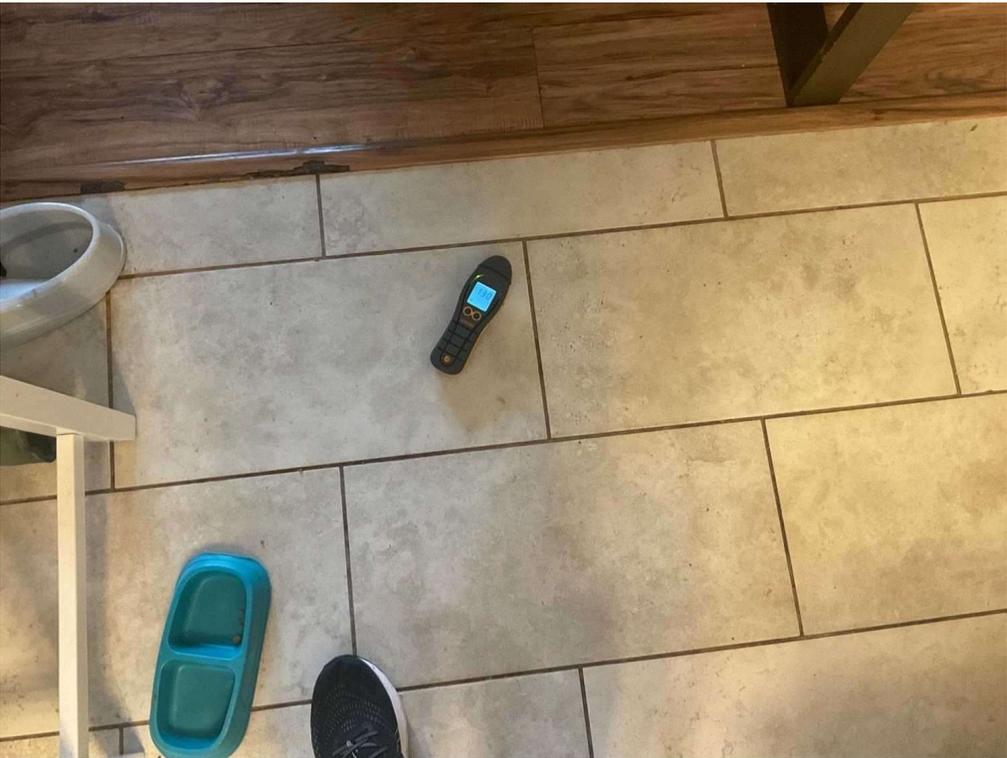
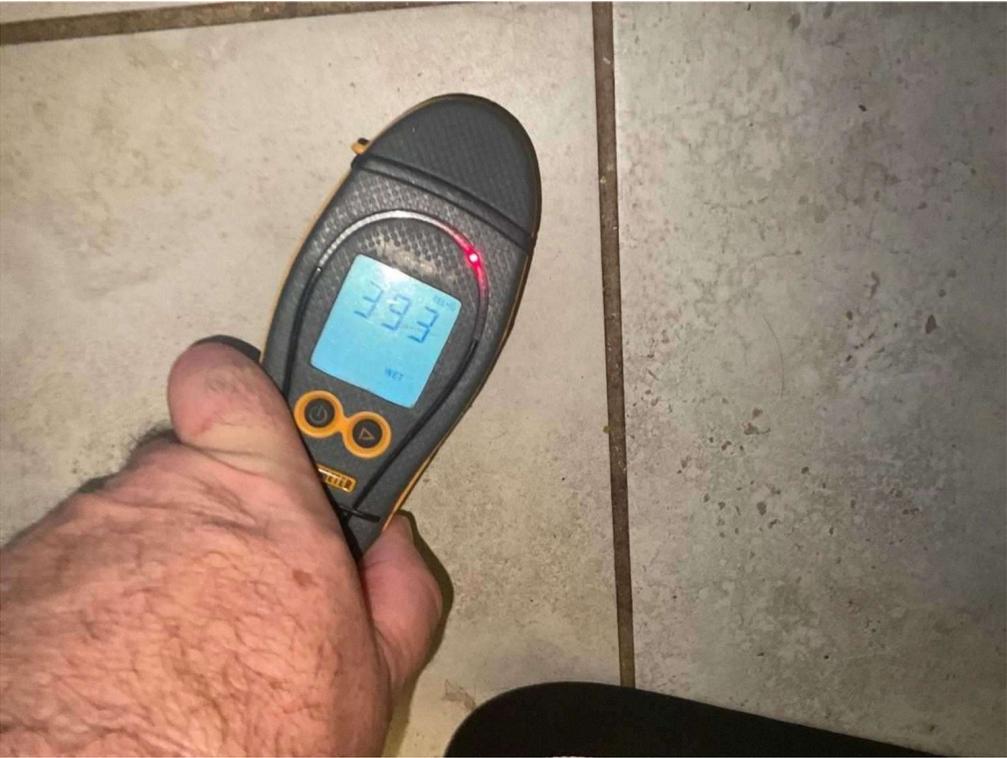
Floor Point 6

393 Elevated

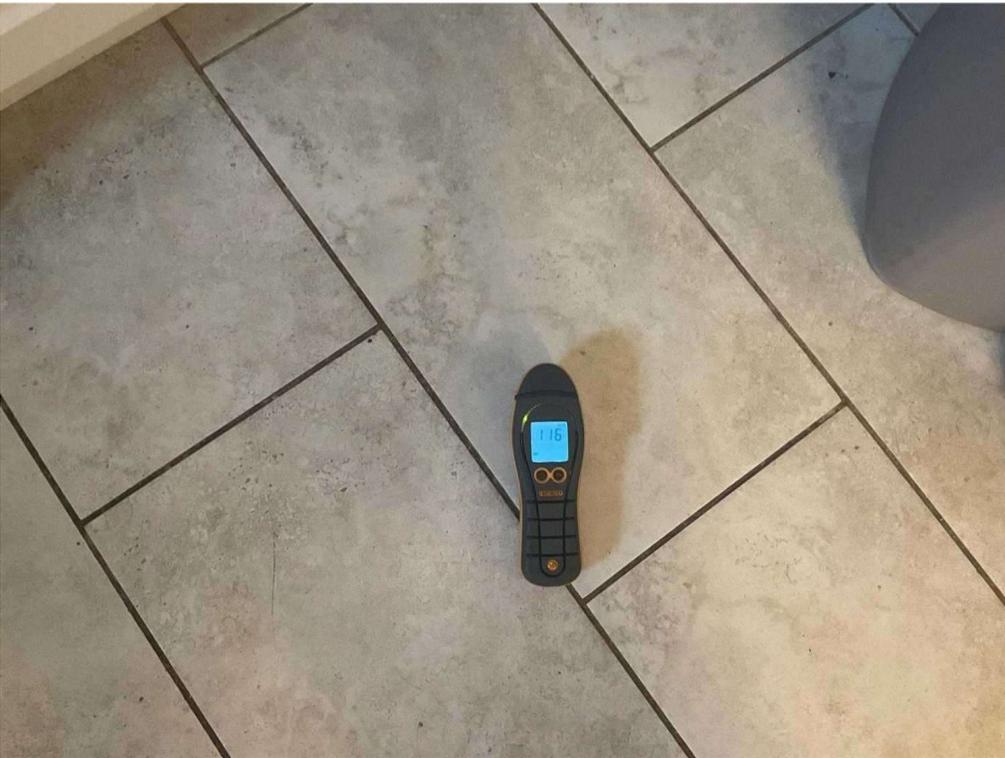
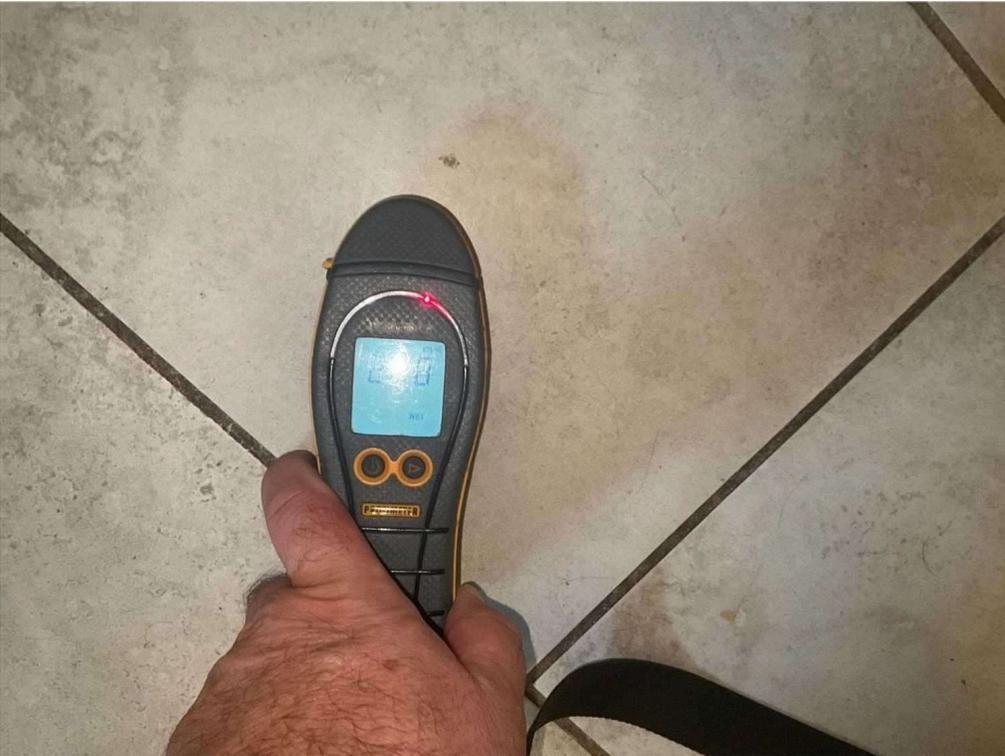
Floor Point 7

238 Dry standard for material

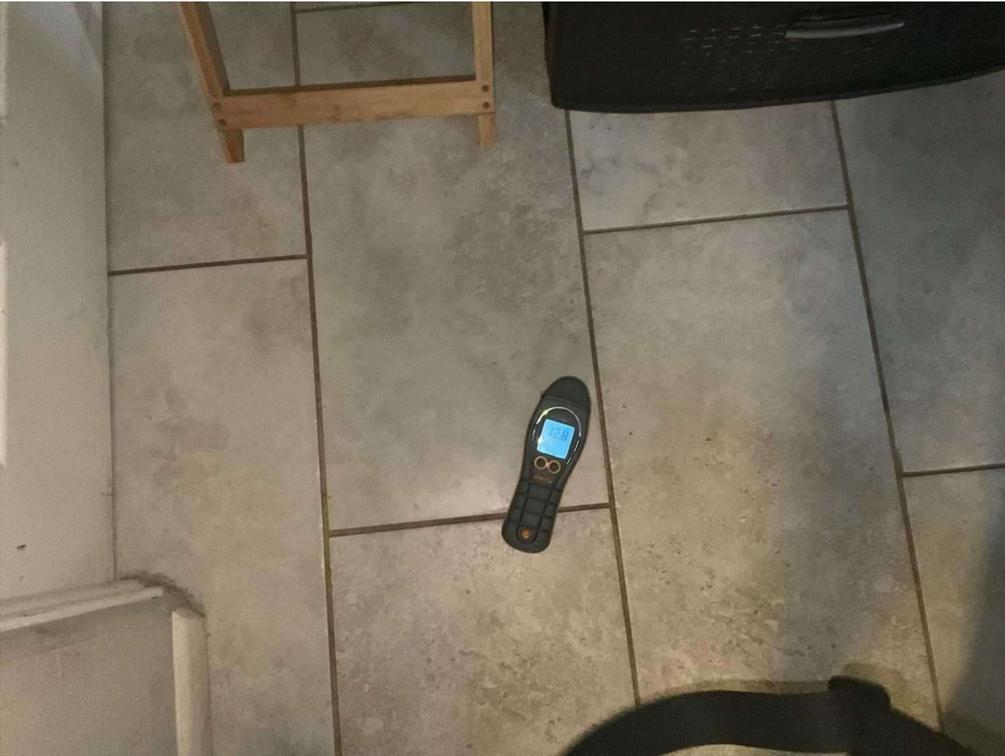
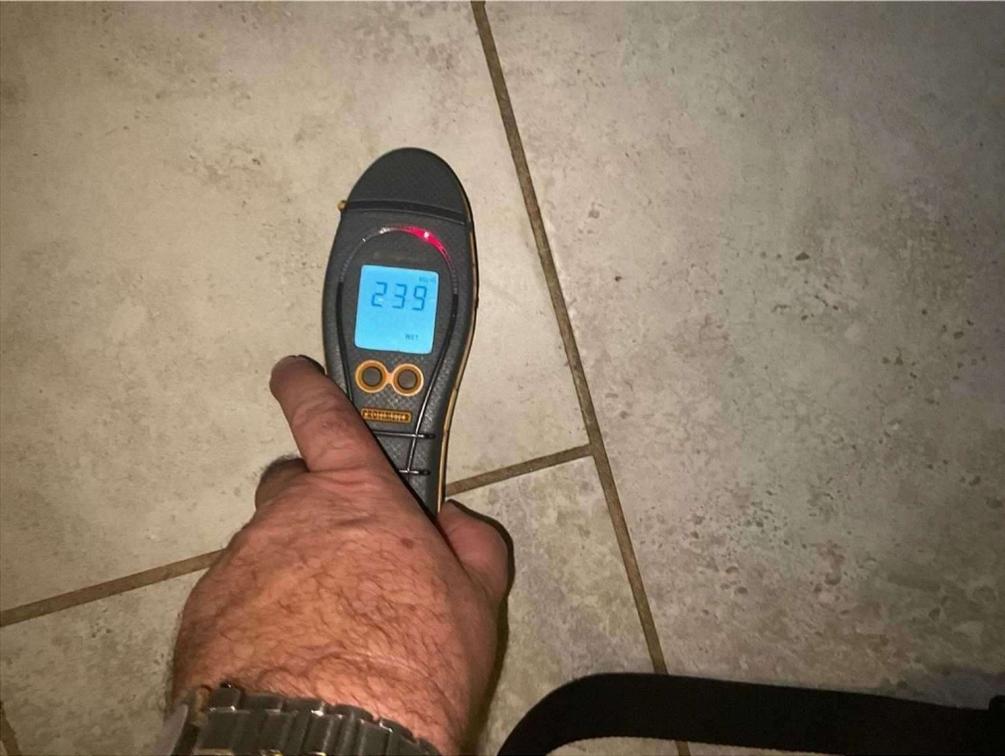
Floor Point 8

239

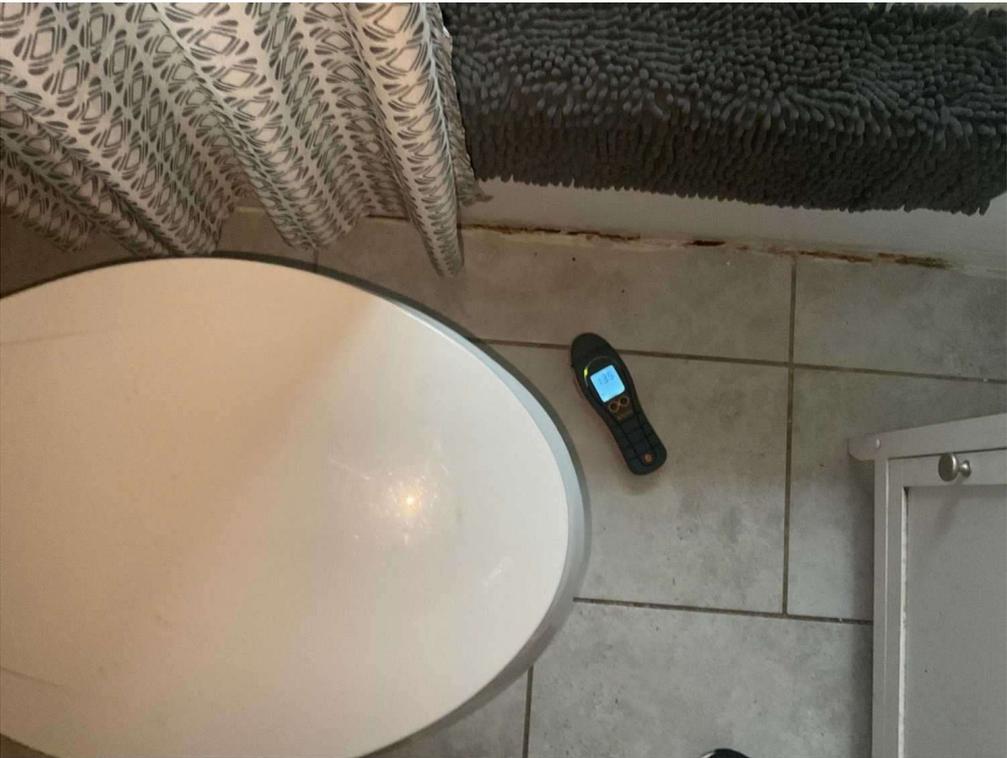
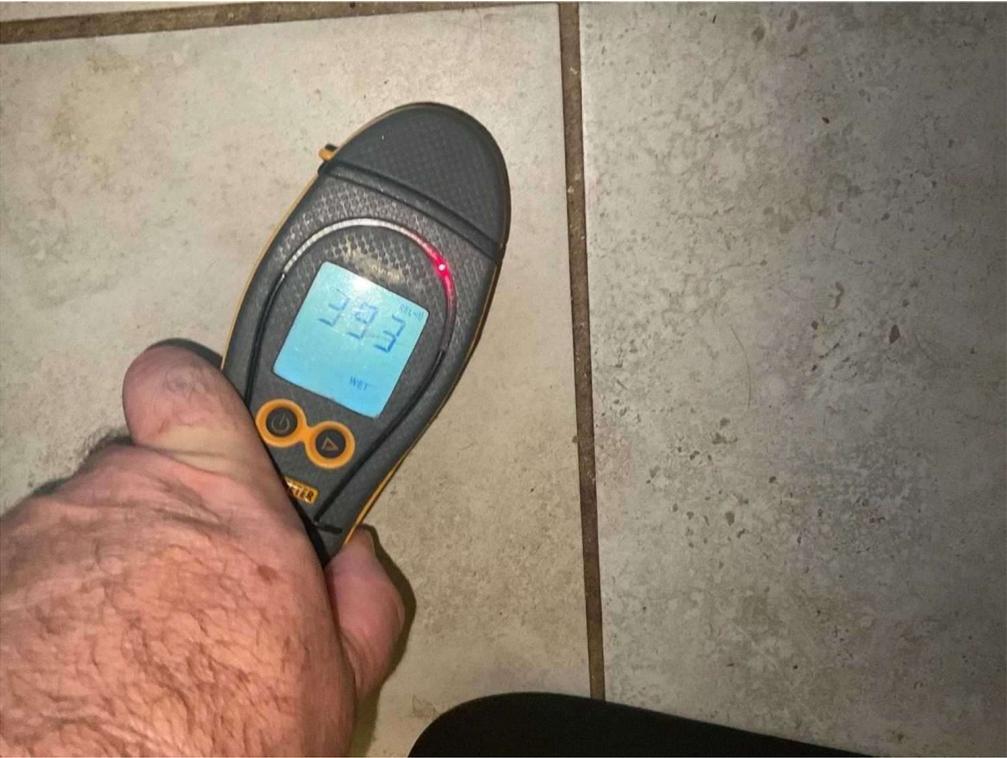
Floor Point 9

393 Elevated

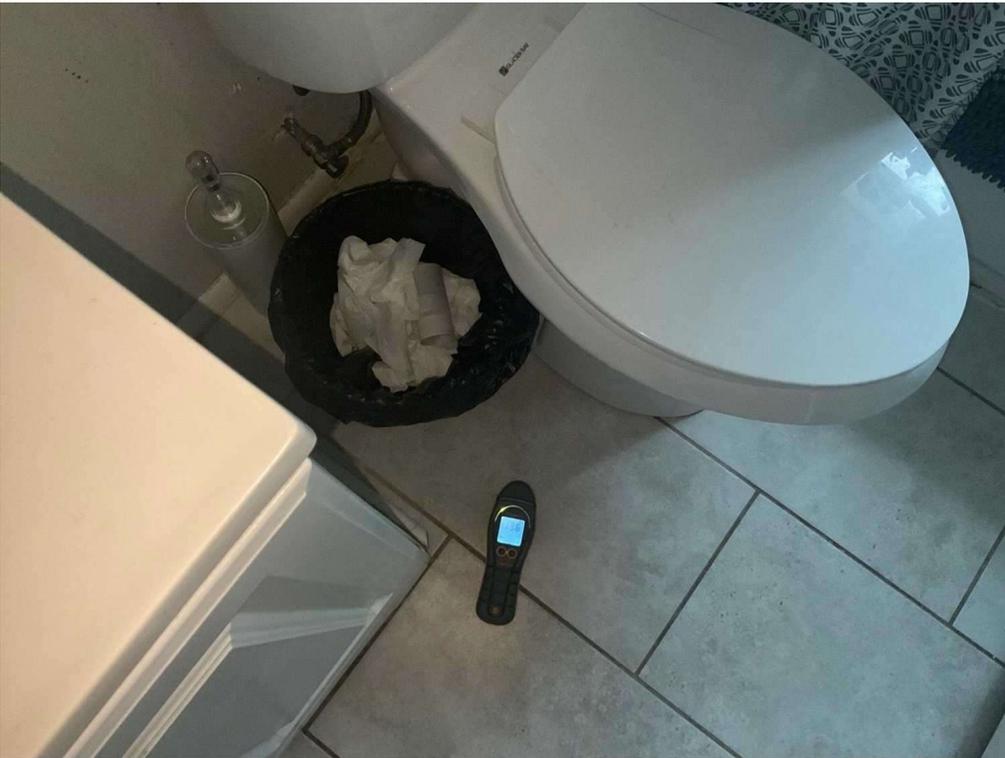
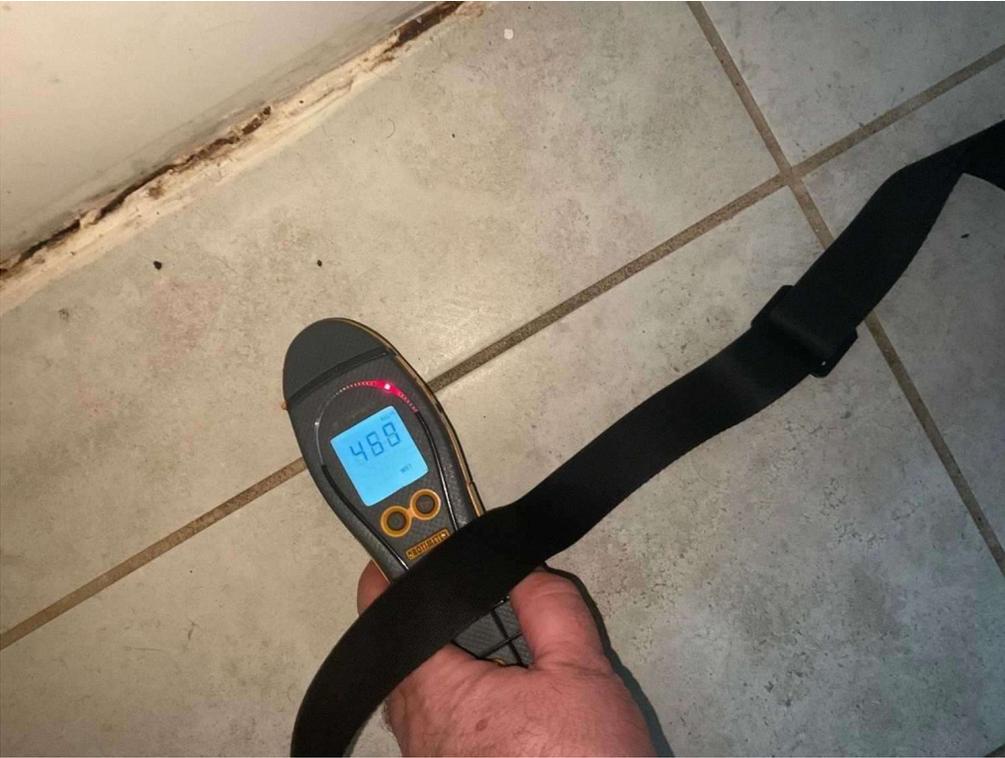
Floor Point 10

468 Elevated

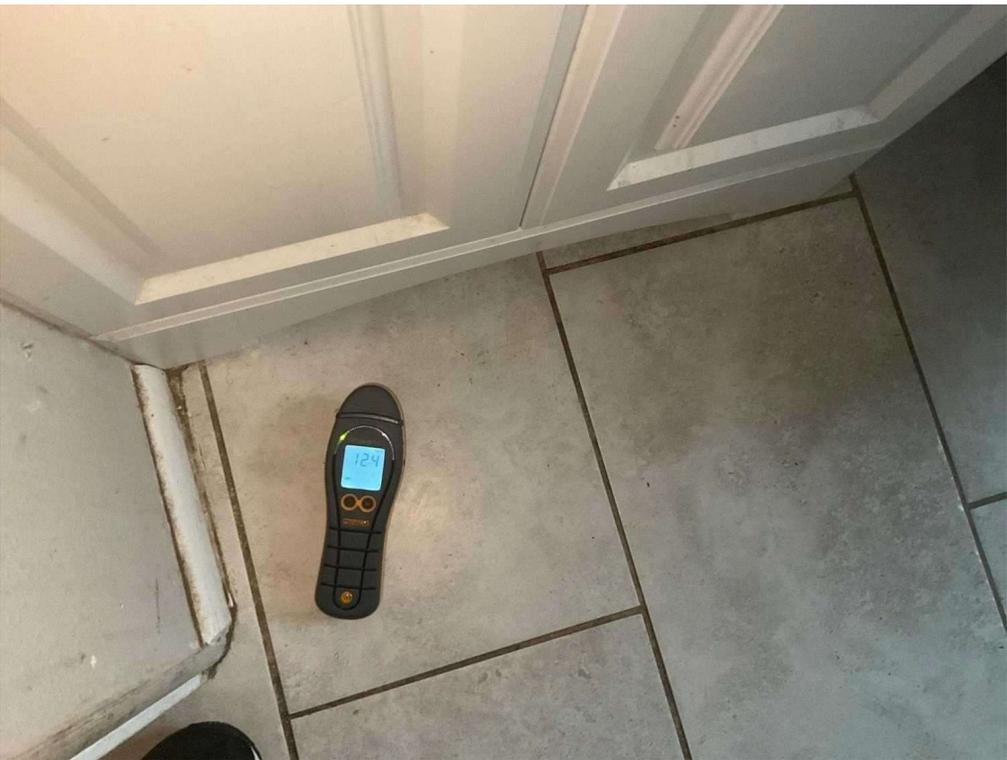
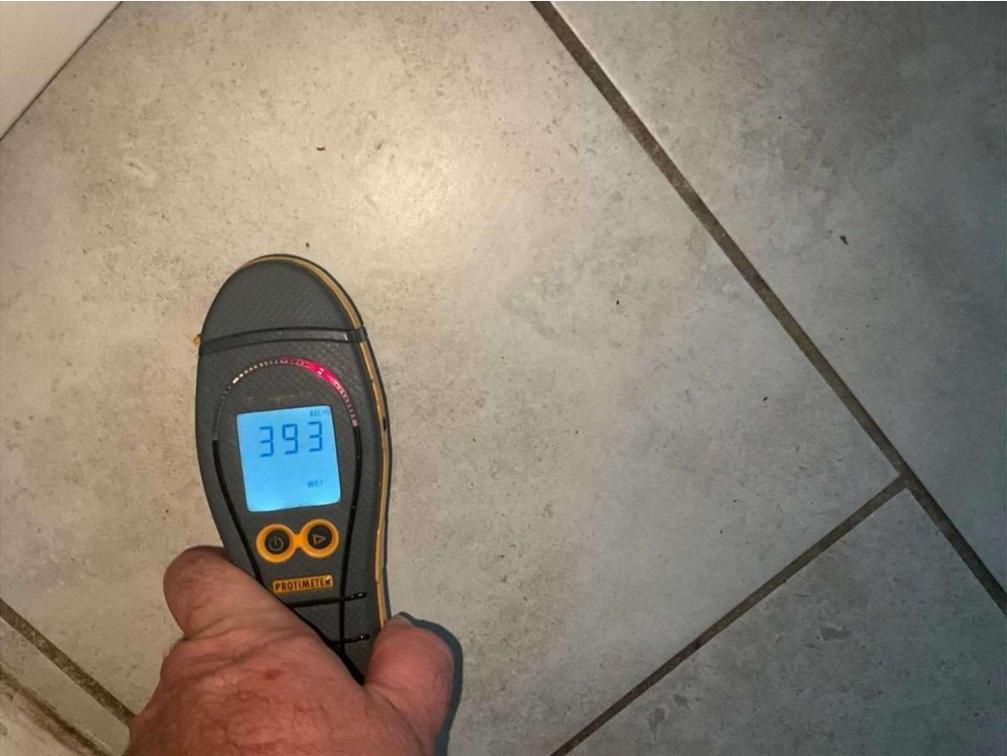
Floor Point 11

393 Elevated

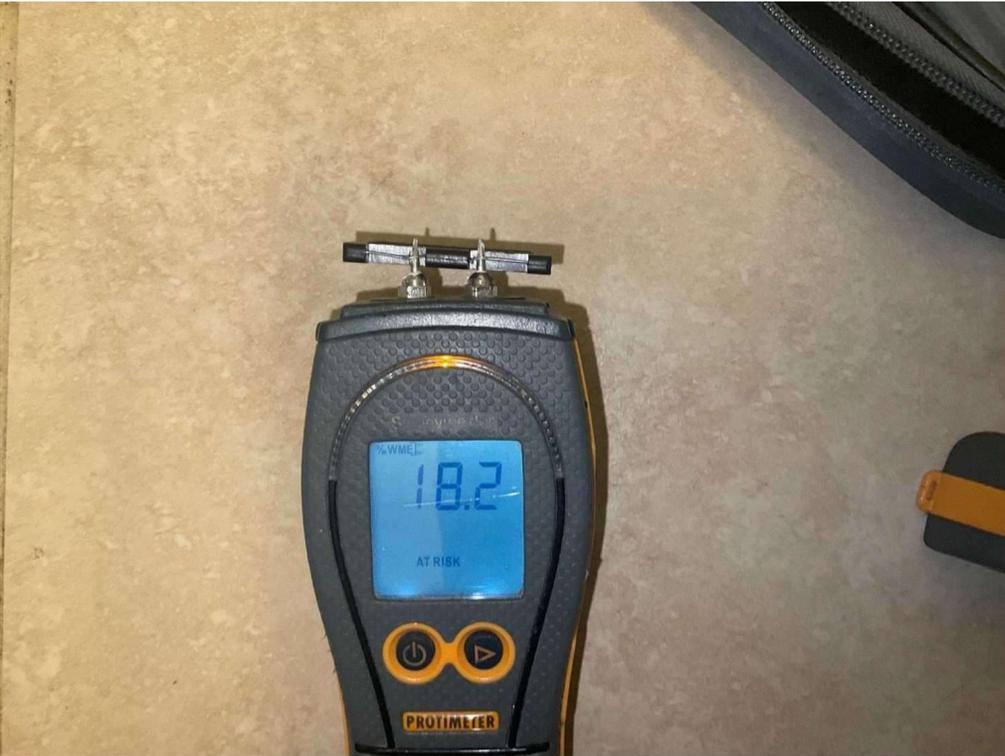
Dwelling > Interior > Moisture

Calibration 18.2%
